Successful retrieval of fractured pressure wire tip (FFR) by hybrid technique

Coronary angiography and angioplasty are relatively safe procedures but not without complications. We report an interesting case of effort angina taken for angioplasty of the LCX and assessment of fractional flow reserve (FFR) for the LAD artery lesion in which the tip of the pressure wire was broken and embolised to the LCX while trying to retrieve it. This is the first case report using a hybrid technique with a slip catheter for the successful retrieval of a fractured FFR wire.

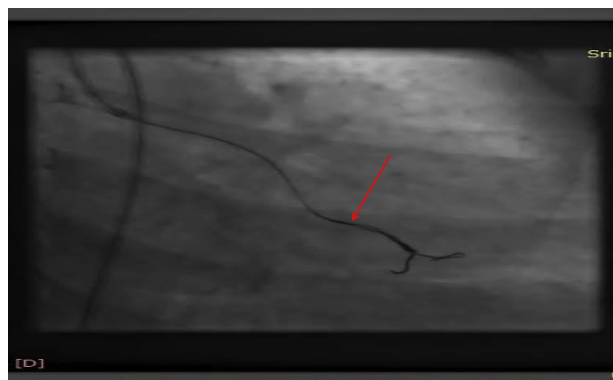
Figure 6. Cine image RAO caudal view showing helix of FFR wire with floppy wire (after migration to OM2).

guidewires to make a helix. Two and three wires were used as more wires can provide greater stability to the helix during manipulation to retrieve the broken wire (Fig. 5). This technique did not help. Due to repeated manipulation, the broken wire migrated to the OM2 (obtuse marginal) (Fig. 6). After repeated attempts in OM2, the helix finally entrapped the broken tip of the pressure wire and all three were pulled back. However, the helix could not be taken out of left main coronary artery (LMCA) due to slippage. The whole procedure took 30 min due to repeated attempts to make a helix and to entrap the pressure wire. We then planned to take an angiographic catheter named Slip-Cath (Cook Medical, SCBR 4.0-38-125-P-NS-VERT), using the mother-child technique, pulling the assembly en masse with the Slip-Cath, keeping in mind a possibility that after making a helix, the Slip-Cath will stabilise the tip of the pressure wire as there will be less place to move or curve around. A 0.014" floppy guidewire (Abbott Vascular, Santa Clara, California) was used to produce a helix with the broken pressure wire, which was then placed under the Slip-Cath and the assembly pulled. (Figs. 7 and 8). Fortunately, our attempt was successful this time. But as soon as the operator pulled the assembly, fluoroscopy was shut down due to a technical problem (while the assembly was at the level of the arch of the aorta; Fig. 9). When fluoroscopy restarted, the wire was hanging at the level of the renal artery, and the helix was open, leaving the fractured FFR wire separated. We could have pulled the wire out with a risk of distal embolisation, but we wanted to be safe. Thus, a 0.014" floppy guidewire was crossed retrograde to preserve the access followed by inflation of a 2.5X10 mm sprinter balloon (Medtronic, Inc., Minneapolis, Minnesota) between the pressure

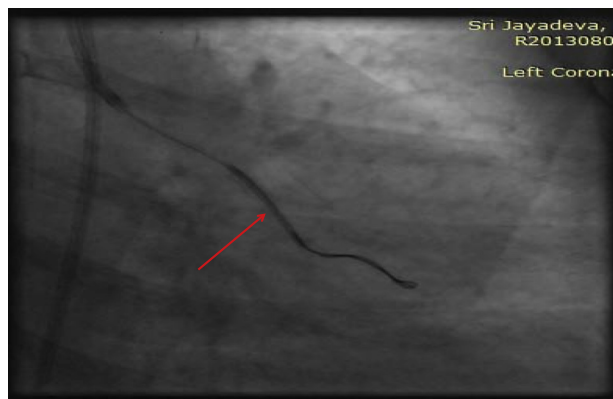
Figure 7. Using Slip-Cath (arrow) with floppy wire to retrieve broken FFR wire from OM2 vessel.
